STRUCTURAL HEALTH MONITORING

xxxxxxxxxxxxx, Hyderabad, Telangana

Measuring Date: 06-03-2026

Task: Structural Health Assessment of Villa

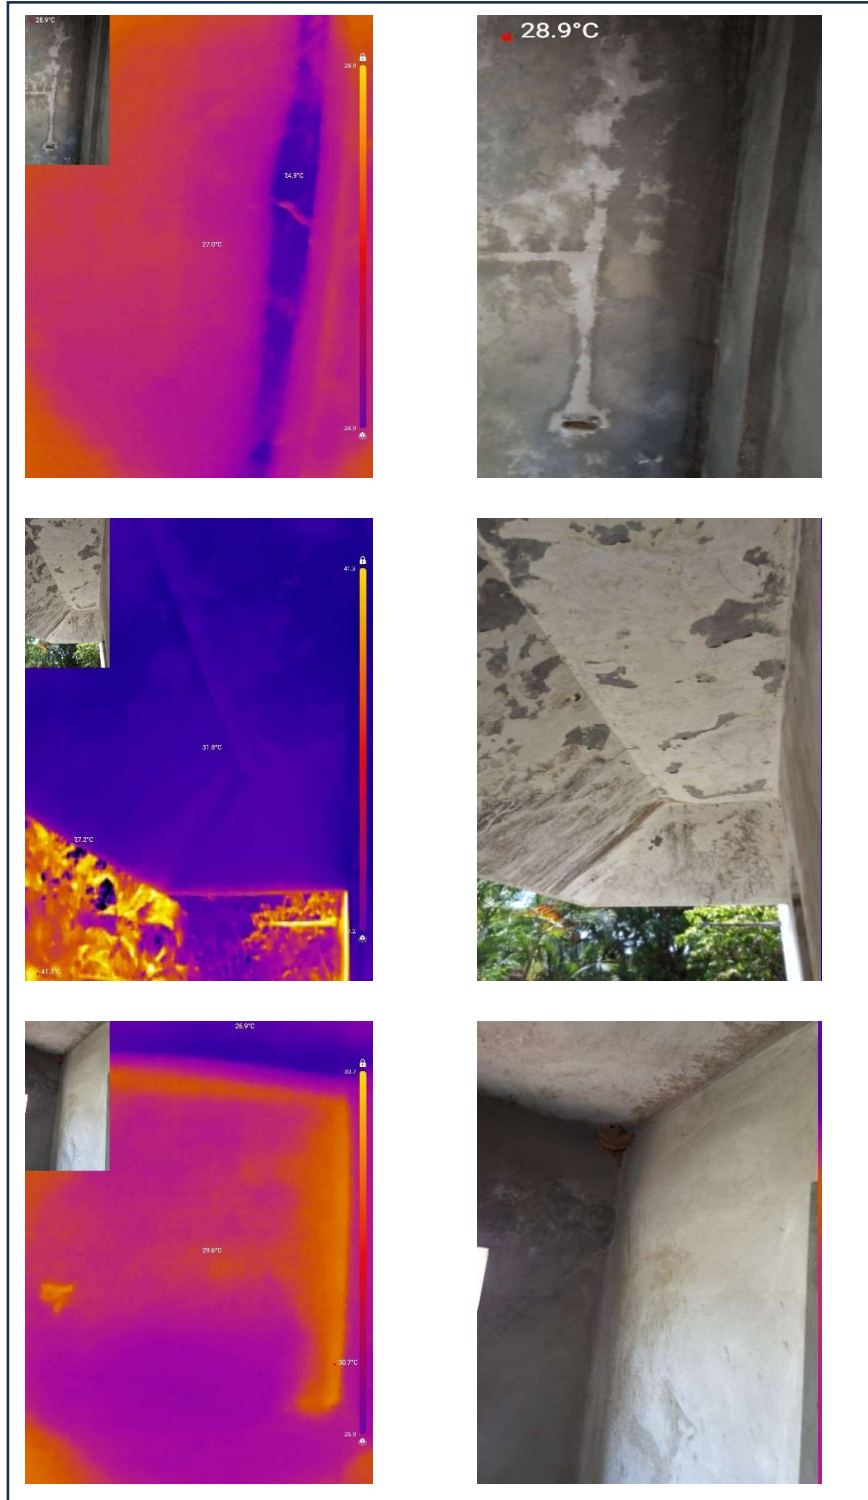
Fig 1: Dampness in a slab refers to the presence of moisture within the slab concrete. It occurs when water penetrates the slab due to improper waterproofing or the presence of cracks. – Grund floor

2. For slabs not exposed to weather, the following rehabilitation procedure is recommended:
 - Carry out crack repairs up to the mother slab.
 - Apply PVC / PU based waterproofing system over the slab surface.

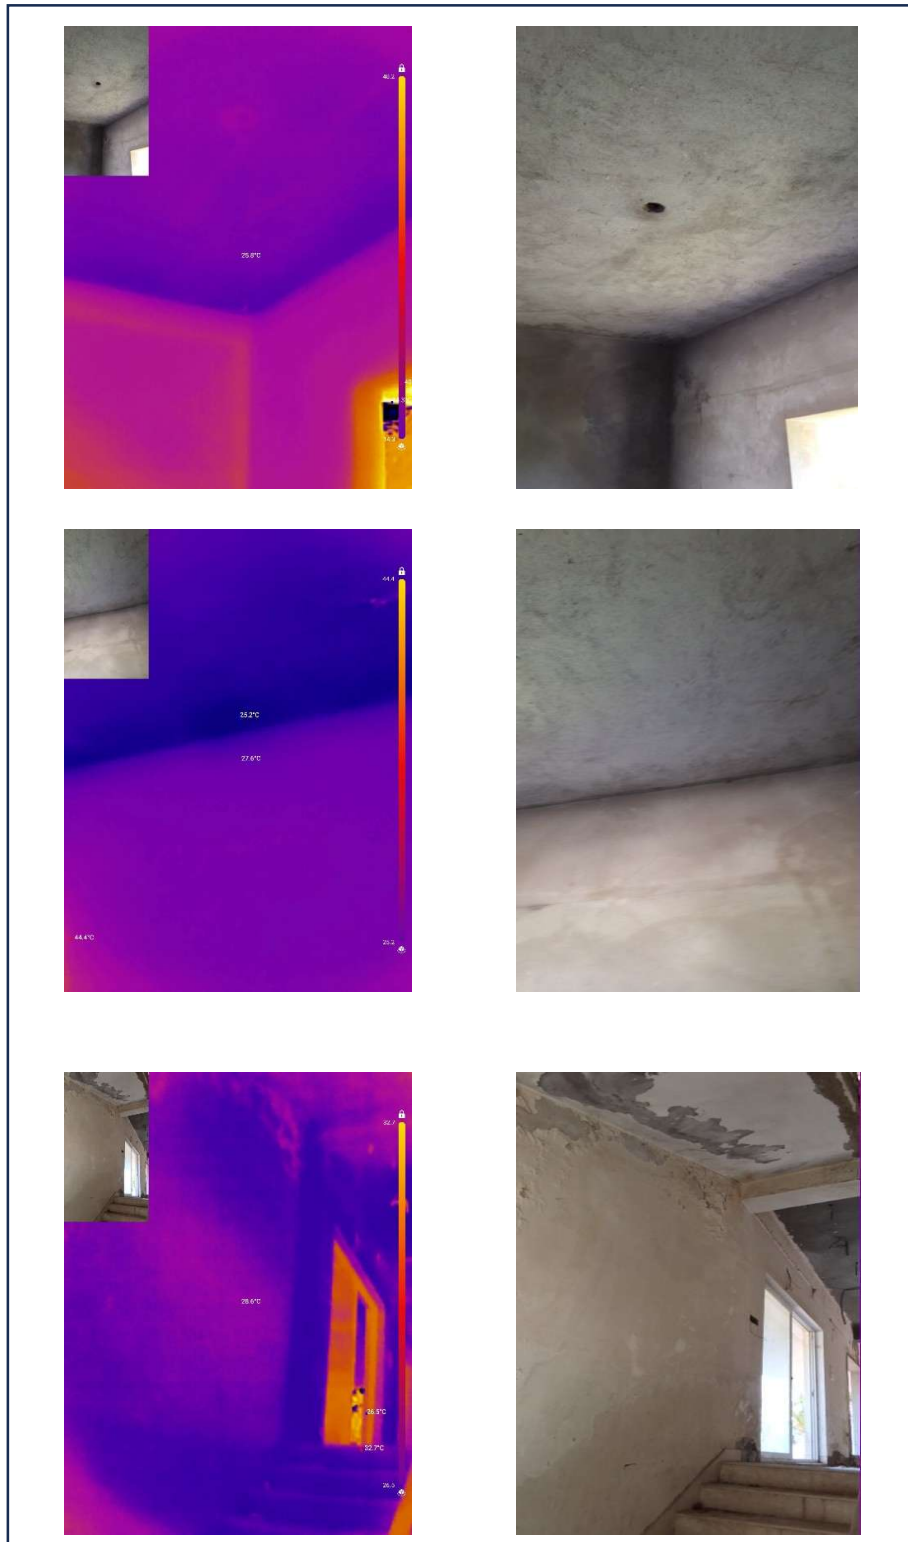
Fig 2: Dampness is observed transferring from the slab to the walls and staircase through the electrical conduit paths. – Ground floor

6. Electrical conduits passing through slabs should be properly treated. Existing conduits causing leakage should either be removed or made inactive (dead) and new electrical lines should be installed along the periphery or through alternative routing to avoid water ingress.

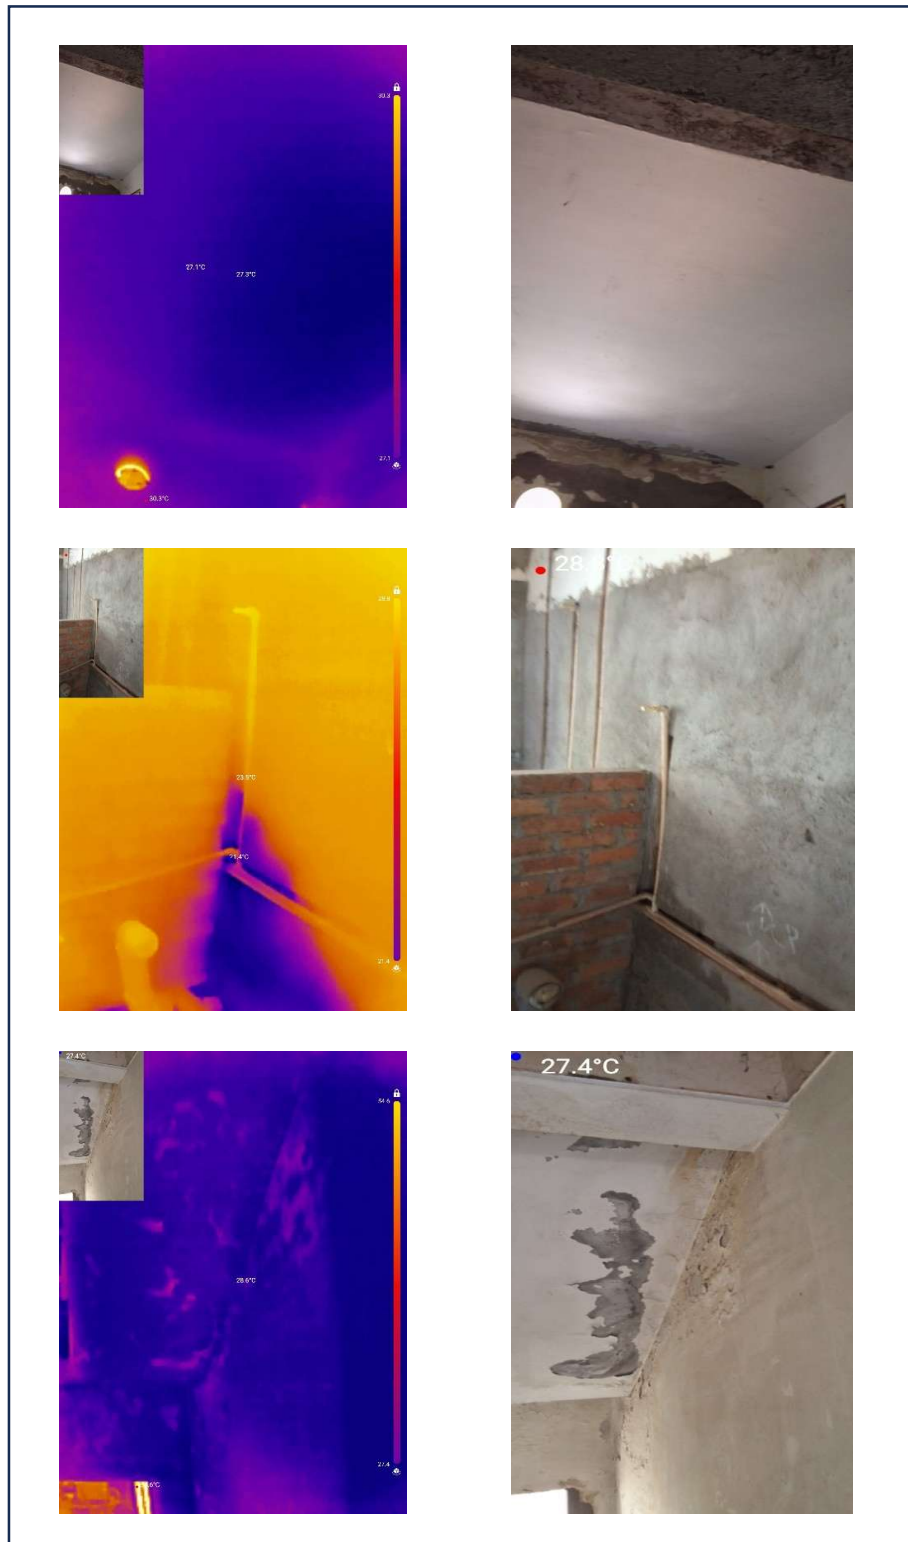
Fig 3: Dampness in the walls and slab is observed due to improper slope for water drainage, resulting in water stagnation and subsequent seepage into the slab. – Ground floor

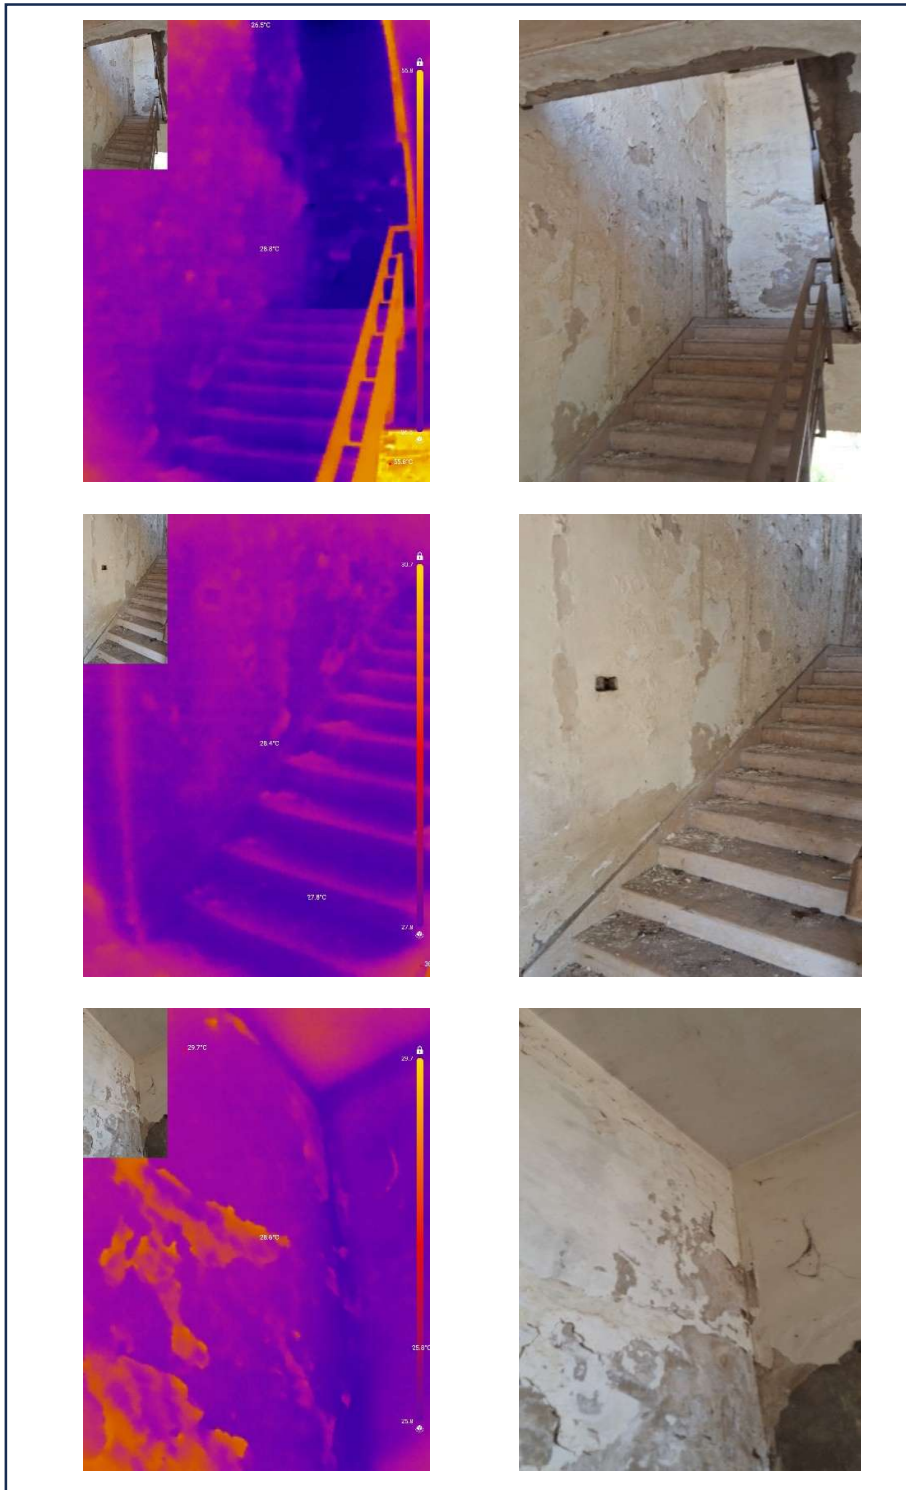
Fig 4: sseepage from the external wall face and the headroom slab due to gravitational flow has been present for a prolonged period, leading to progressive deterioration of the wall and steps.

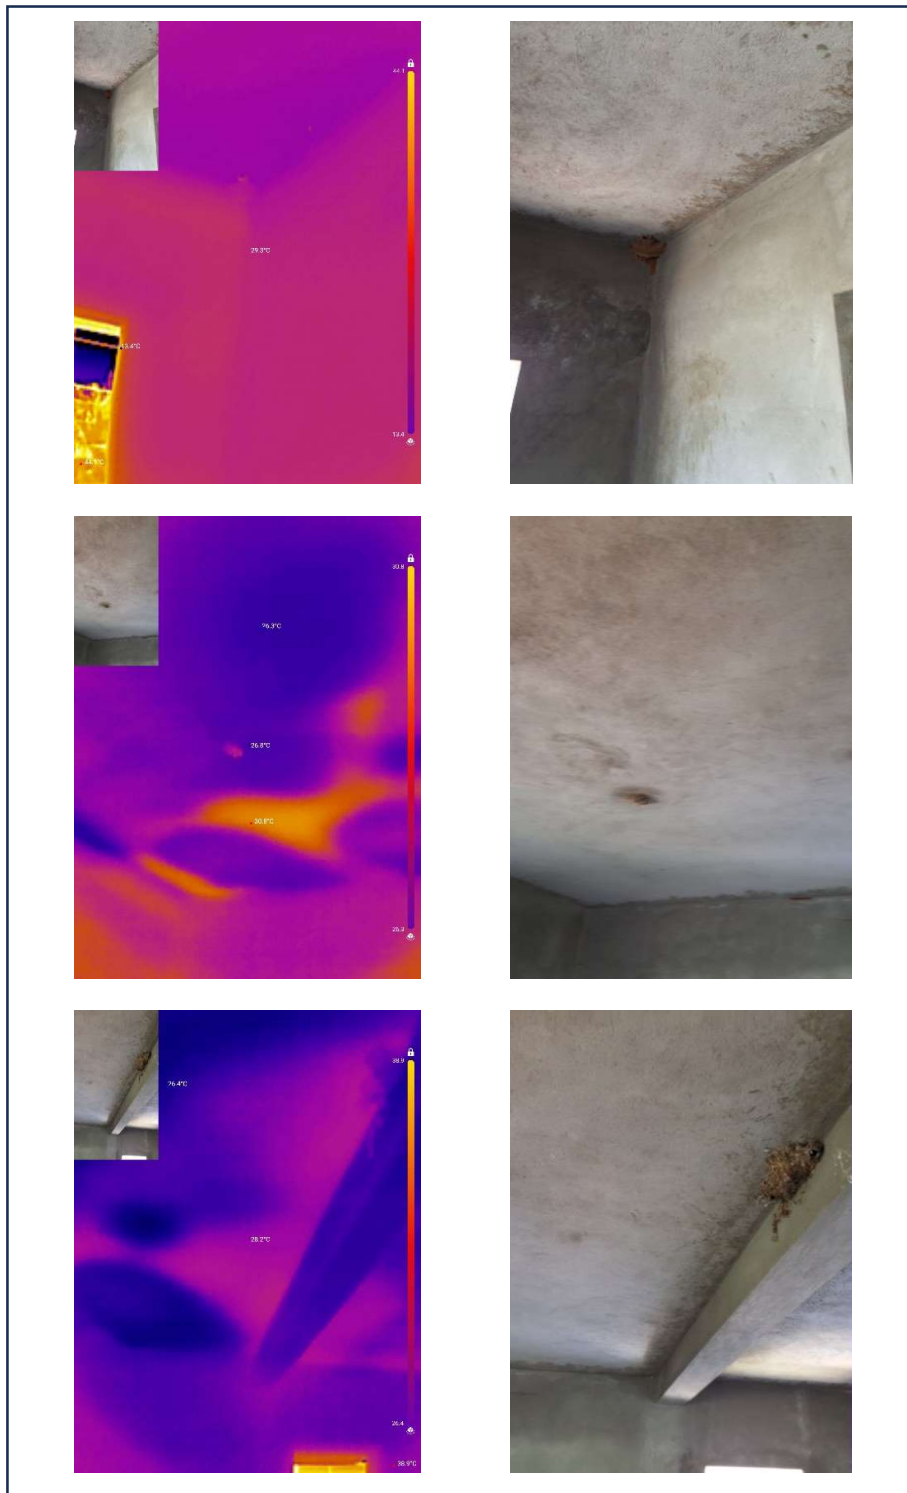
Fig 5: Severe damp patches are observed on the slab due to water stagnation on the surface and ingress of water into the concrete. Prolonged exposure of raw concrete to weather has led to moisture penetration and development of cracks. – 2nd floor

4. For terrace slabs exposed to weather, the following system is recommended:
 - Remove the existing wearing coat completely.
 - Perform crack repair treatment on the mother slab.

- Provide re-screeding using high-strength polymer modified mortar with proper slope.
 - Apply APP membrane waterproofing system with protective layer.

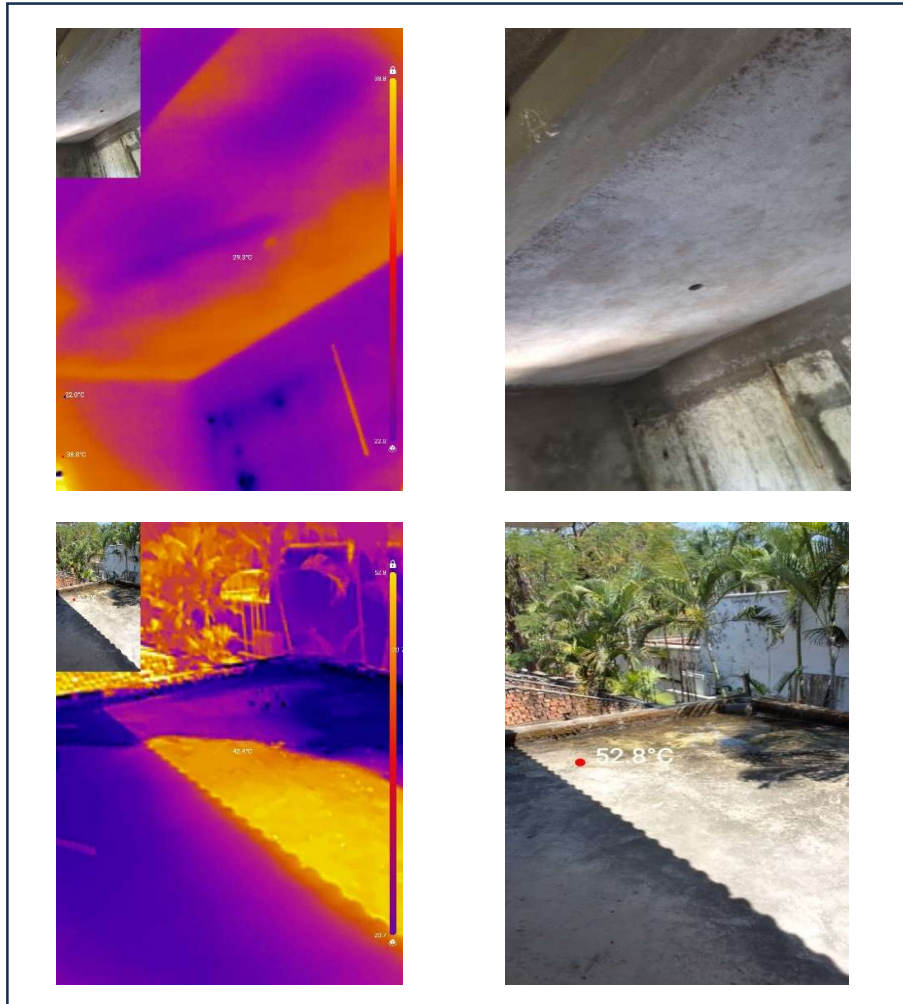
Fig 6: Water stagnation on the slab due to improper slope has resulted in penetration of water through electrical conduits and seepage into the slab soffit along the conduit path. -2nd floor

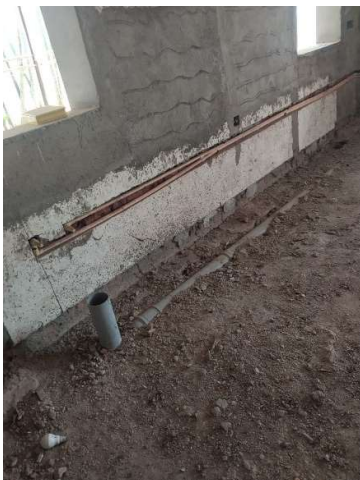
Fig 7: Termite activity is observed originating from the wooden pieces used as plumbing fixers. – Ground Floor

1. Anti-termite treatment shall be carried out throughout the building. At least three cycles of termite treatment are recommended to completely eliminate termite infestation originating from wooden plumbing fixtures and embedded organic materials.

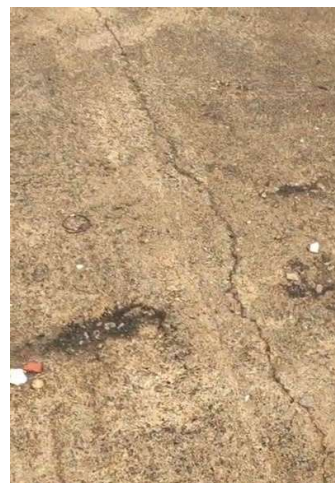
Fig 8: 20mm crack is observed on the 1st floor front balcony for a length of about 25ft which lead to progressive deterioration of slab

5. A **20 mm wide crack** is observed on the **front balcony slab**, extending approximately **25 ft in length**, indicating progressive deterioration of the slab.
6. Debonding of slab concrete is observed indicating **Stage-3 deterioration**.
7. Dampness is observed on the slab through **electrical conduit paths**, and prolonged moisture exposure has led to deterioration of the slab.

5. At the 1st floor balcony slab, complete crack repair up to the mother slab shall be carried out. The repair area should extend at least 2 ft radius on either side of the crack to ensure effective treatment and bonding.

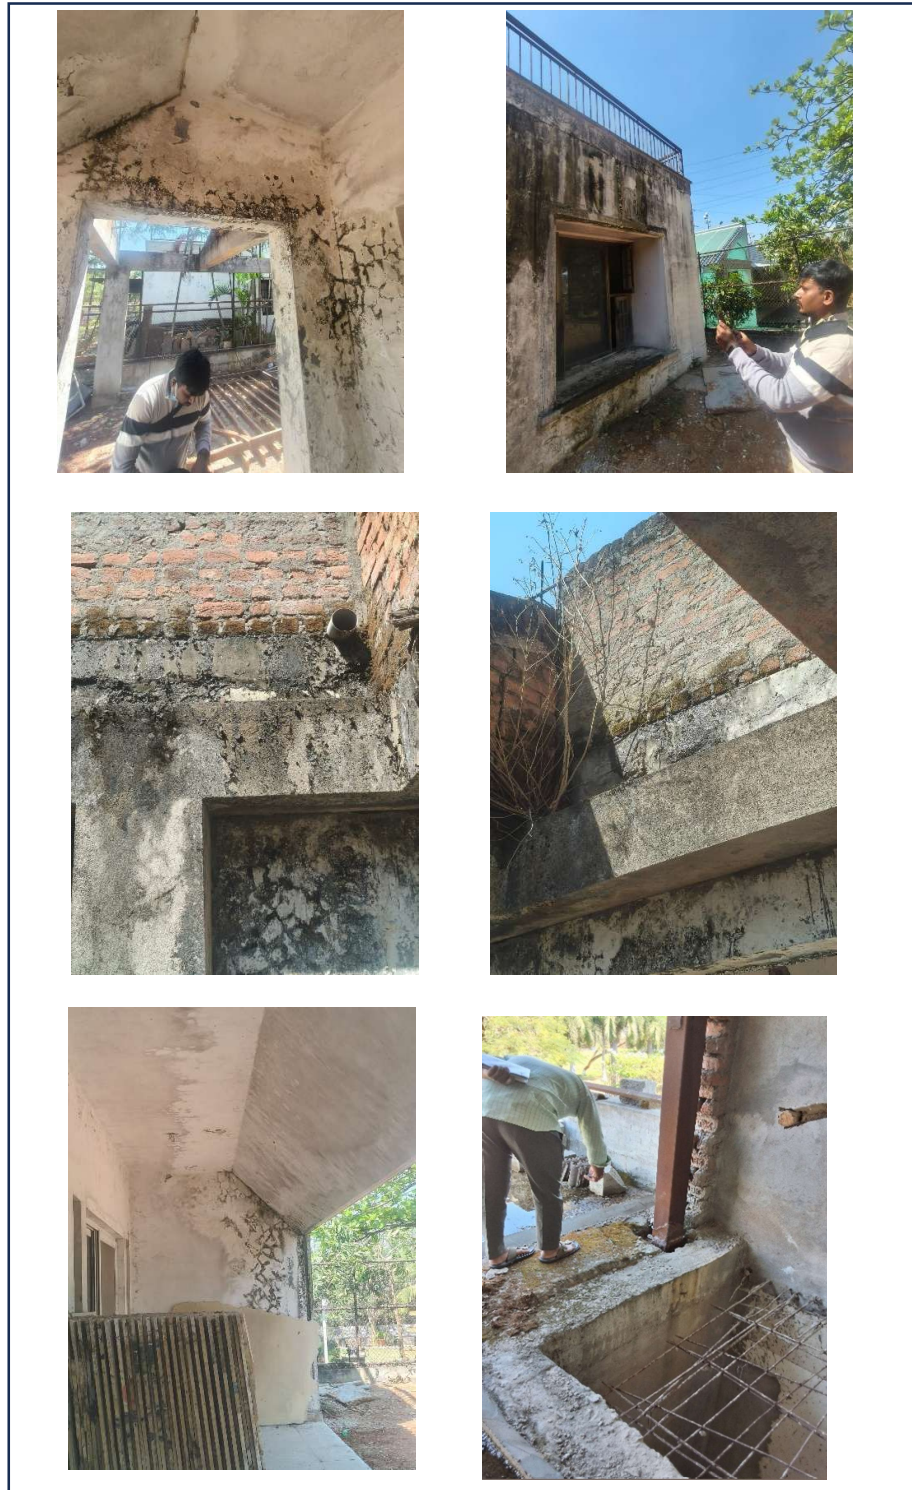
Fig 9:1. Water leakage from the slab into the walls, caused by improper compaction of concrete and absence of waterproofing on the slab, has deteriorated up to **Stage-3** .
due to improper maintenance. 2. Structure being unused and non-maintained, plantation observed on the structural elements.

11. Vegetation and plantation on slabs and structural members must be completely removed, and the affected surfaces should be cleaned and treated before repair works.

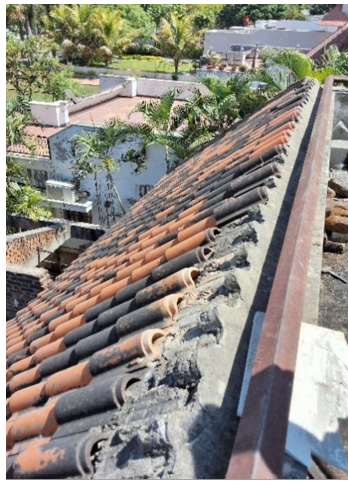
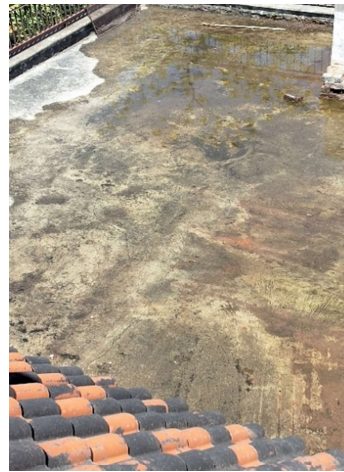
Fig 10: Loosening of Mangalore tiles in the elevation has resulted in water ingress into the slab, leading to further deterioration of the slab.

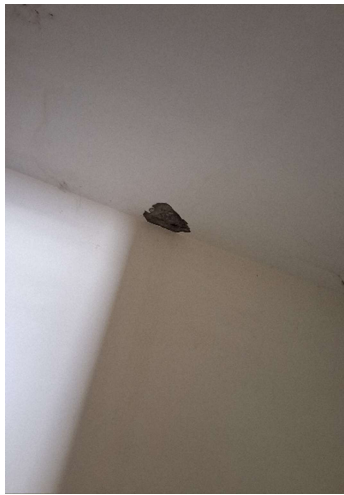
Fig 11: Debonding of the slab has occurred, leading to **Stage-3 deterioration**. – 1ST floor

- Provide protective screed with proper slope.
 - Finish the surface with tile flooring after completion of waterproofing.
3. Epoxy pressure grouting shall be carried out at locations exhibiting severe deterioration and structural cracks to restore monolithic action of the concrete.

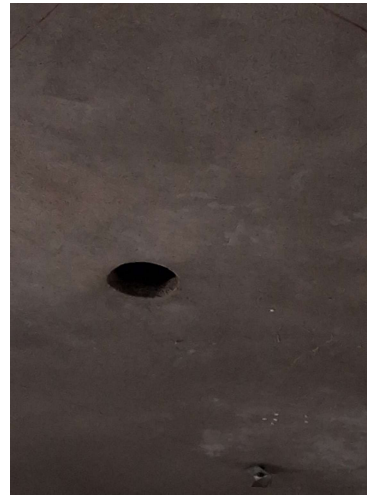
Fig 12: Dampness is observed on the slab through electrical conduit paths, and the continued moisture presence has led to deterioration of the slab. 1ST floor

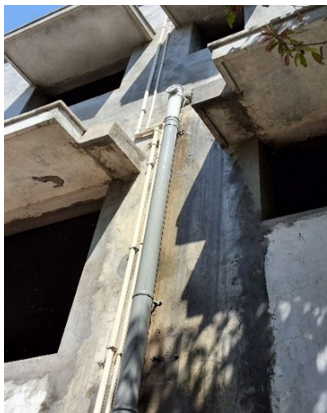
Fig 13: Improper packing of drain outlets in walls and slab lead to leakage of overflown water to the below structure causing damage to the adjacent walls, beams.

9. All deteriorated plaster and loose concrete should be removed up to sound substrate and repaired using polymer modified repair mortar.
10. Drain outlets and rainwater pipes should be reinstalled or repaired with proper slope and sealing to prevent overflow water leakage into the structure.
